Chicago Transit Authority - Strategic Planning
 Blue Line Forest Park Branch Feasibility / Vision Study

Existing Conditions Assessment Report Kedzie-Homan Station

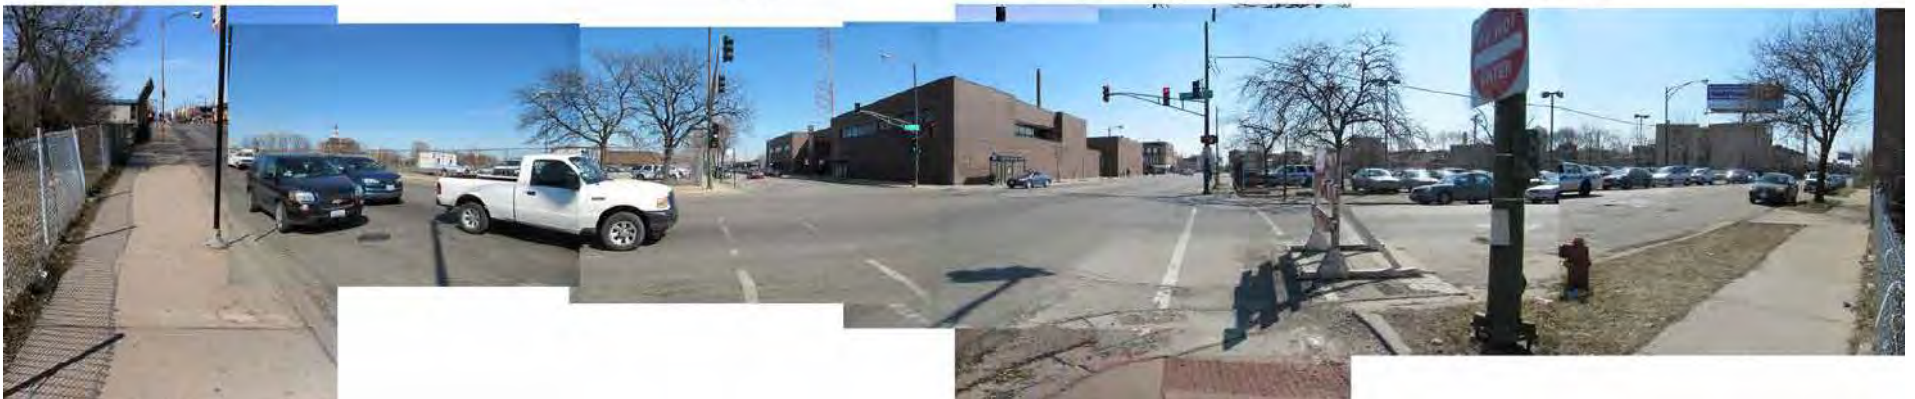
HARRISON
STREET
WEST

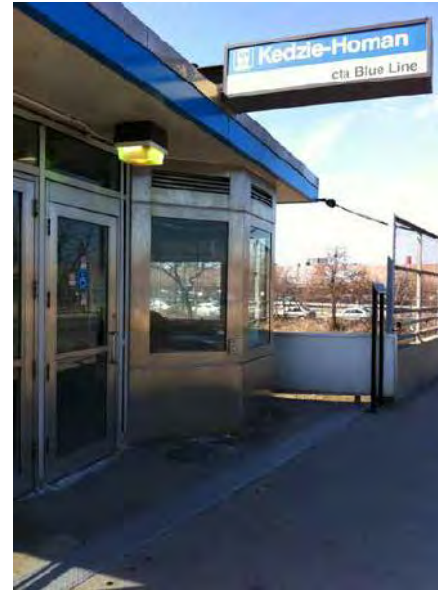
View of stationhouse entry at Kedzie Avenue. Note newer doors, storefront and customer service kiosk positioned at front

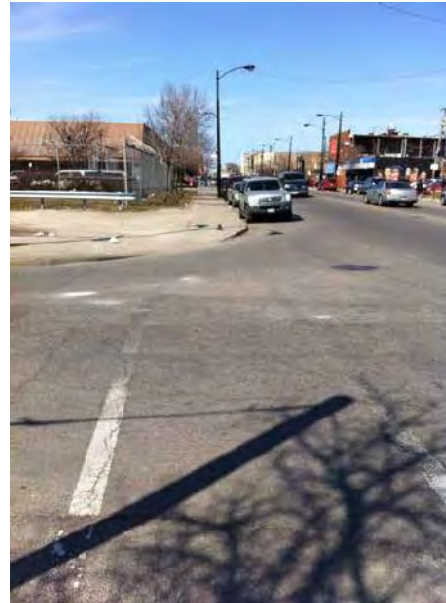
View of non-compliant curb ramp at Kedzie Avenue on approach to station. Note that the pedestrian crosswalk is not well identified with striping.

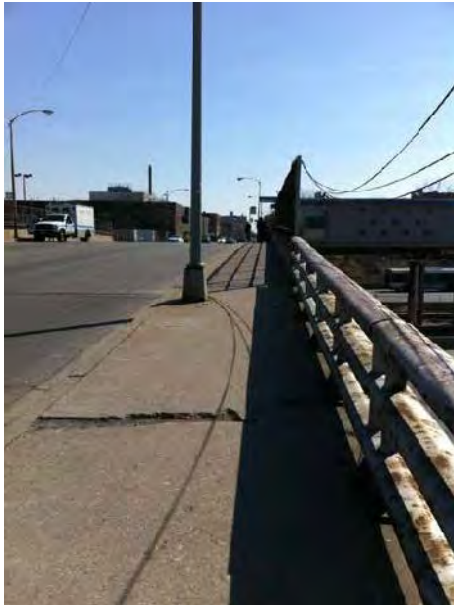
View of sidewalk along Kedzie Avenue on approach to station. Note cracked concrete sidewalk that should be repaired.

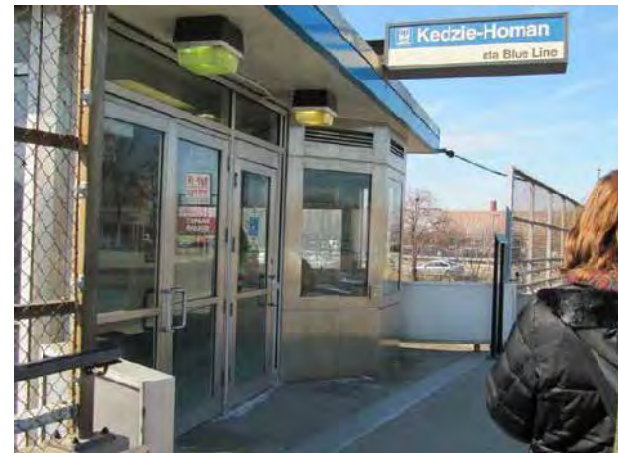
View of newer compliant entry doors at Kedzie Avenue Stationhouse

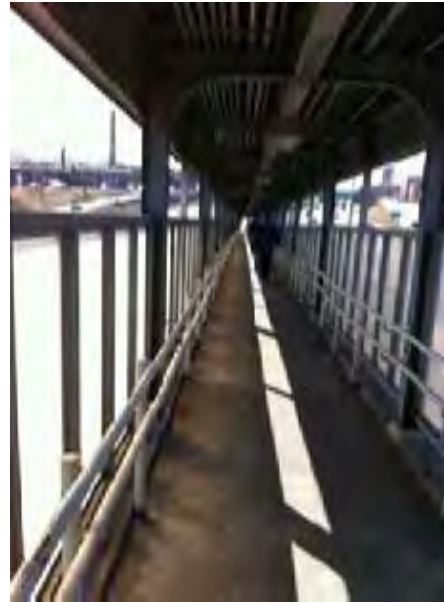
View of exit ramp at east end of platform

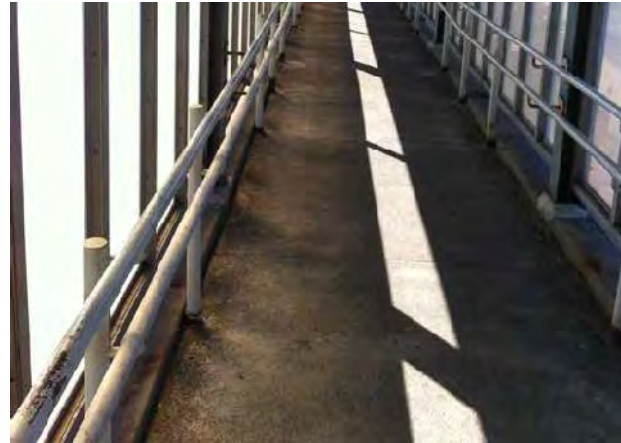
View of corrosion and rusting at posts of handrails on ramps. Note peeling paint on railings, and aged plastic panels on windbreaks.

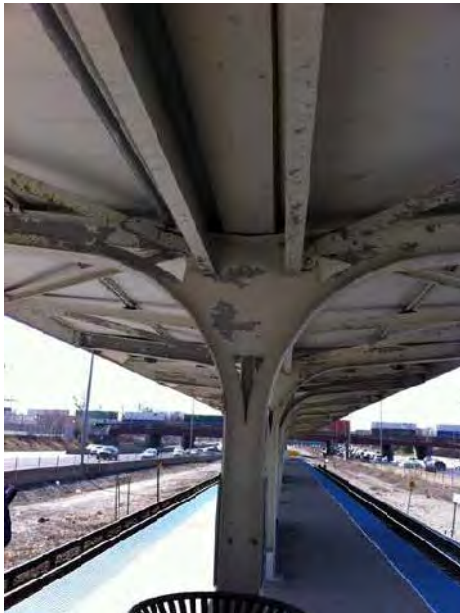
View of peeling paint and rusting conduit at platform canopy structure

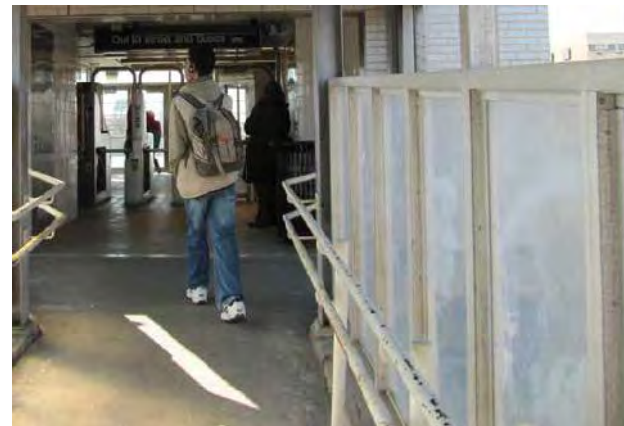
View of corroded surfaces and aged plastic panels of wind break enclosure at ramp

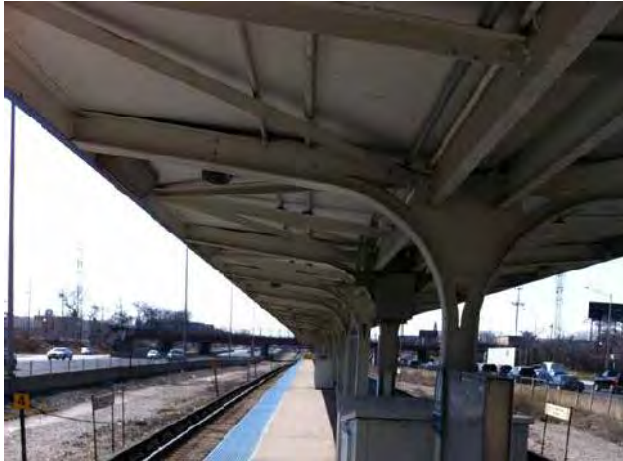
View of corrosion and peeling paint at underside of platform canopy

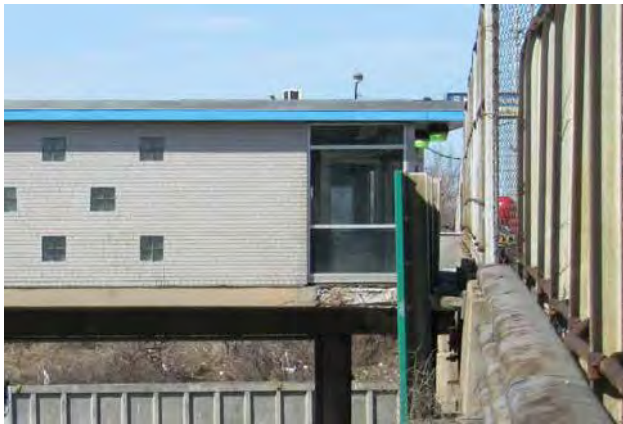
View of spalling concrete at base of Kedzie Stationhouse walls, rusting and loose concrete is evident.

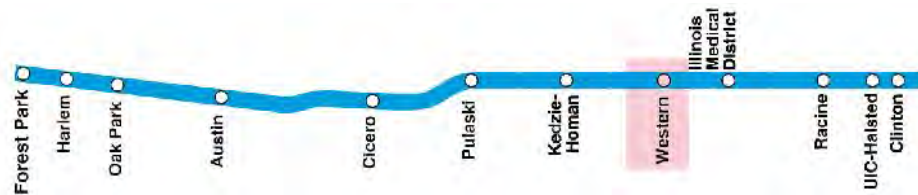
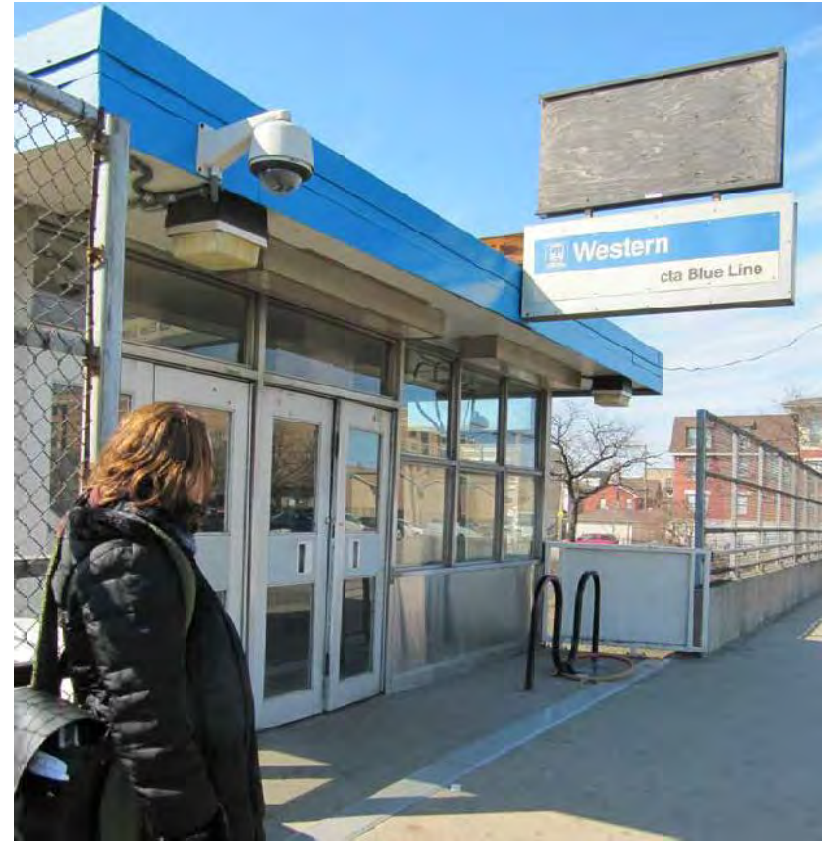
Chicago Transit Authority - Strategic Planning
 Blue Line Forest Park Branch Feasibility / Vision Study

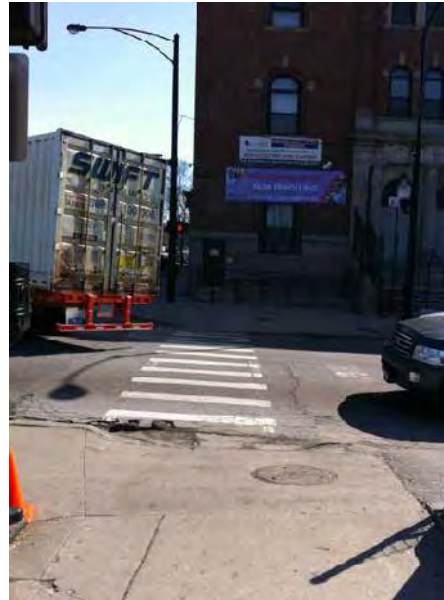
View of non-compliant curb ramp at Western Avenue and Congress intersection on approach to station. Note that the road within the crosswalk is also in need of repair

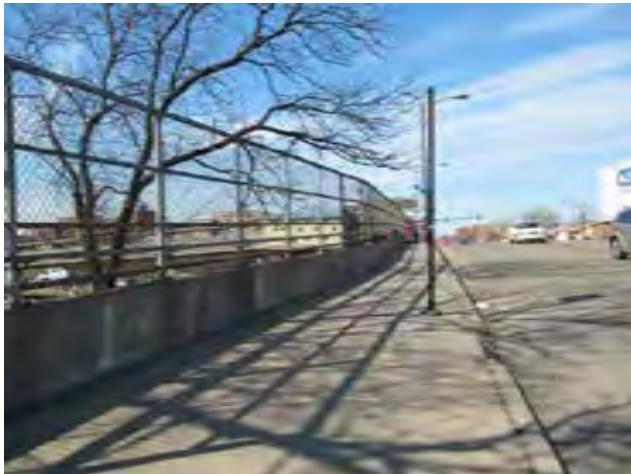
View of sidewalk along Western Avenue on approach to station

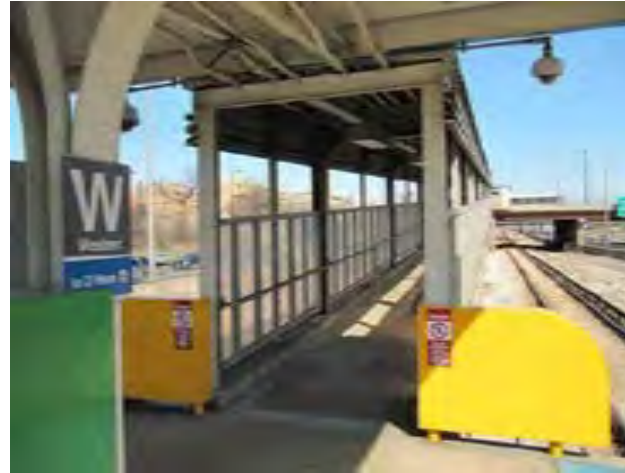
View of exit ramp at east end of platform

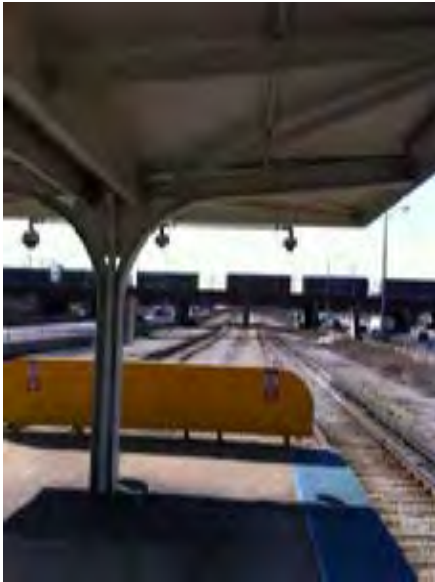
View of west end of platform. Note pedestrian bridge in the distance is visible.

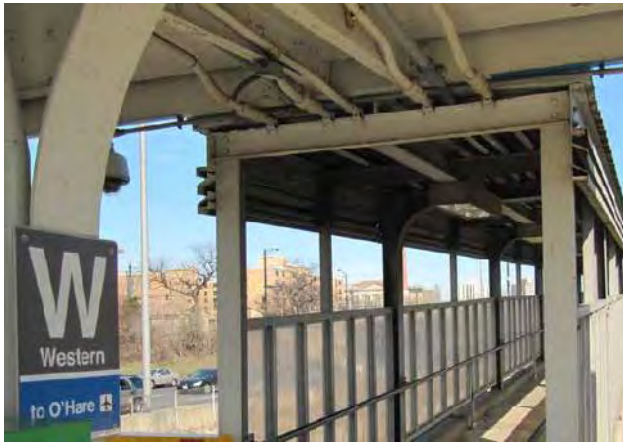
View of peeling paint and rusting conduit at platform canopy structure

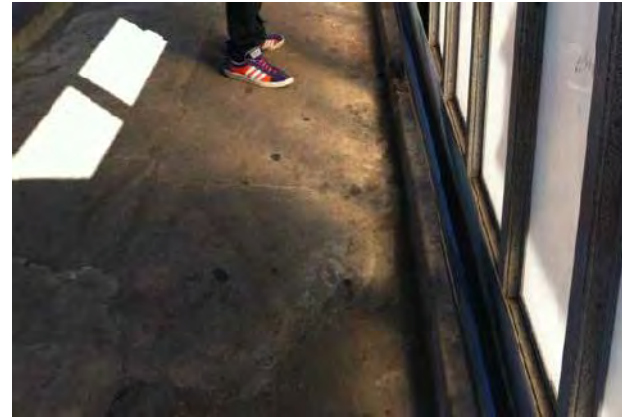
View of broken uneven patches at ramp surface

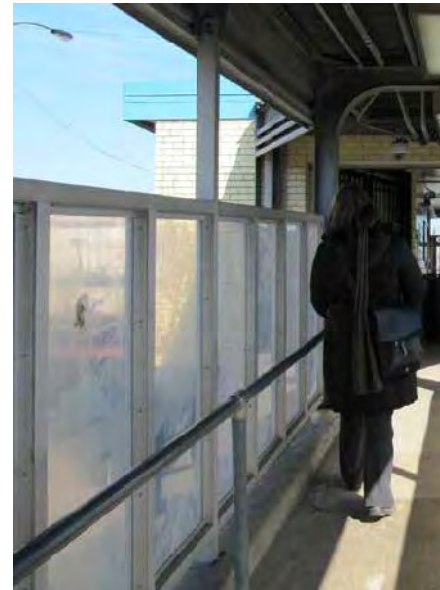
View of corrosion and aged plastic panels of wind break enclosure at ramp

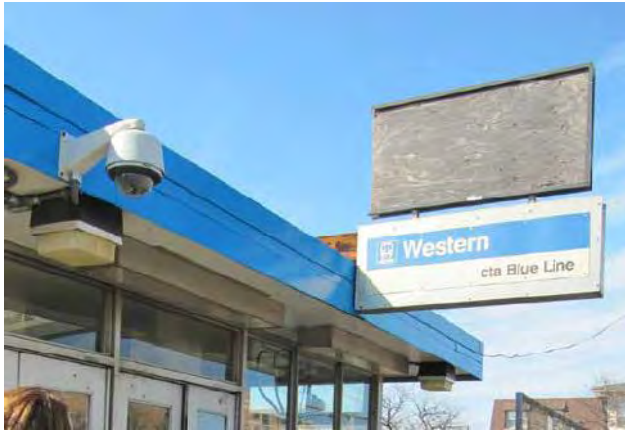
View of station identifier sign and unused advertising panel.

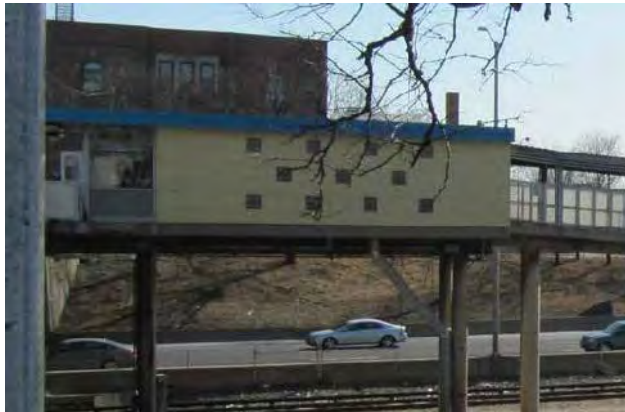
View of stationhouse exterior showing spalling at concrete at base of the wall

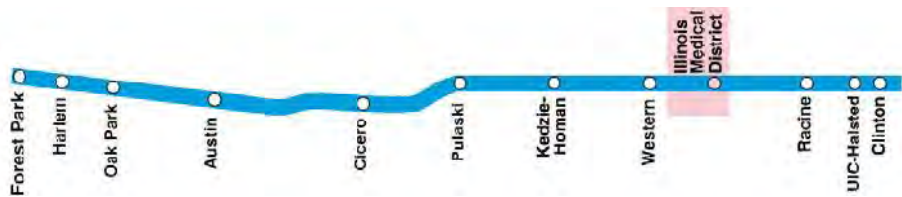
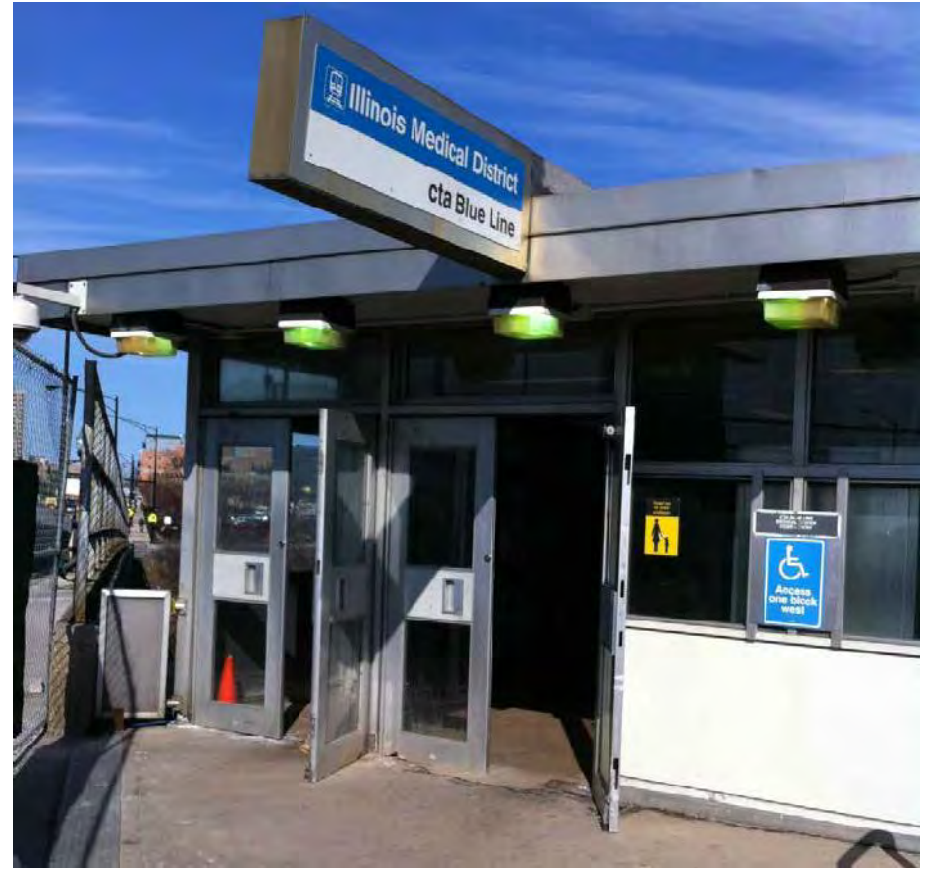
Chicago Transit Authority - Strategic Planning
 Blue Line Forest Park Branch Feasibility / Vision Study

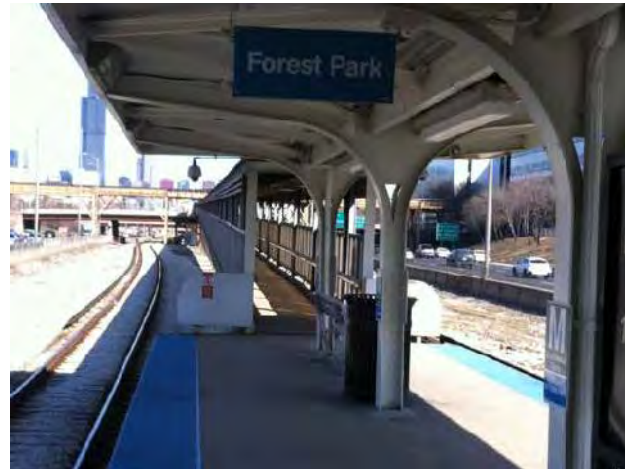
View of exit ramp at east end of platform

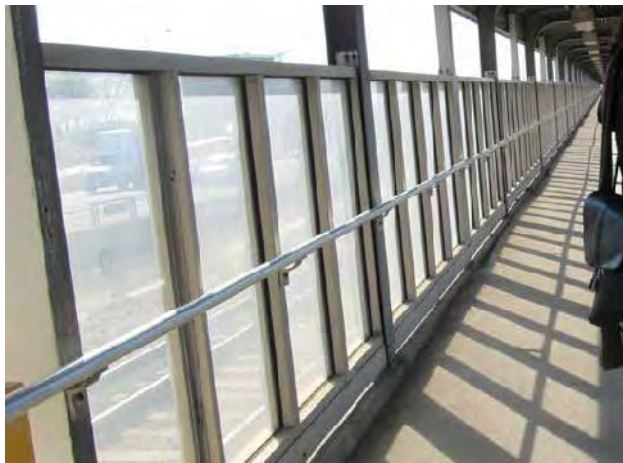
View of corrosion and scratched wind break panels at ramp.

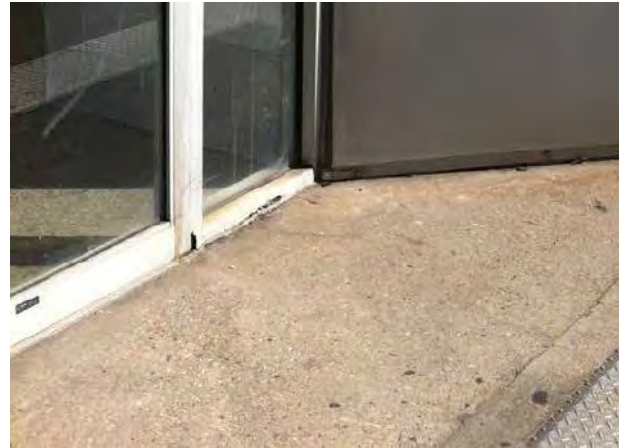
View of deterioration at the base of newer storefront at Damen stationhouse.

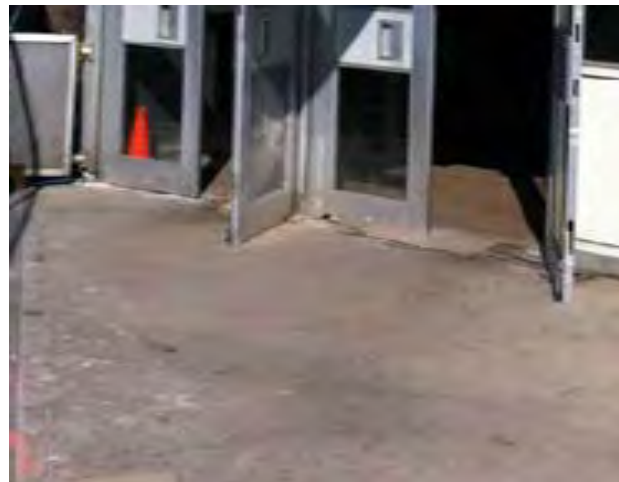
View of deterioration at the base of doors and storefront at Ogden stationhouse.

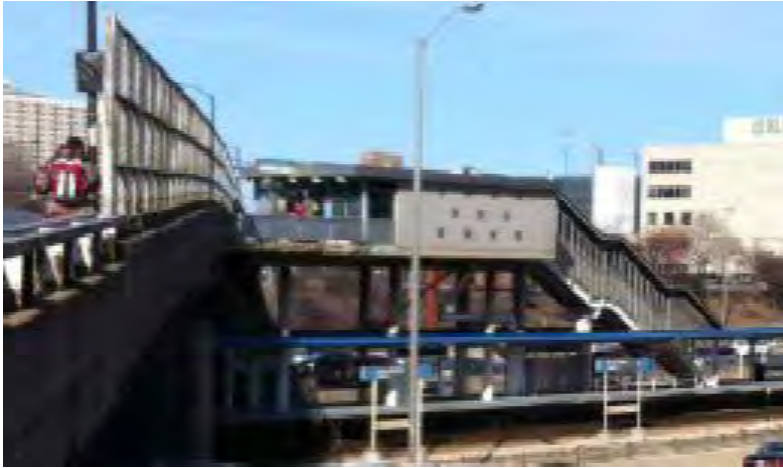
View of corrosion and deterioration at concrete base at Ogden stationhouse

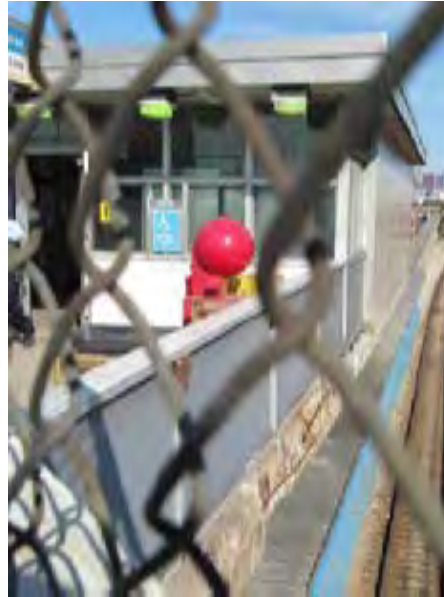
View of corrosion and deterioration at concrete base at Ogden stationhouse

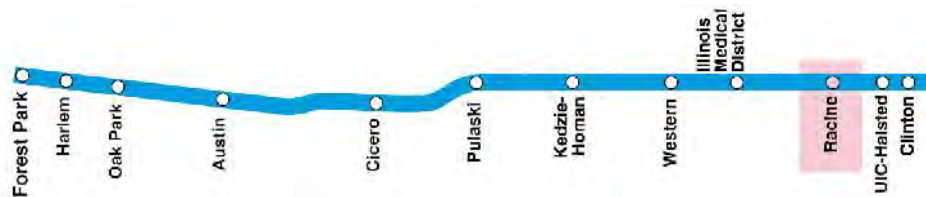
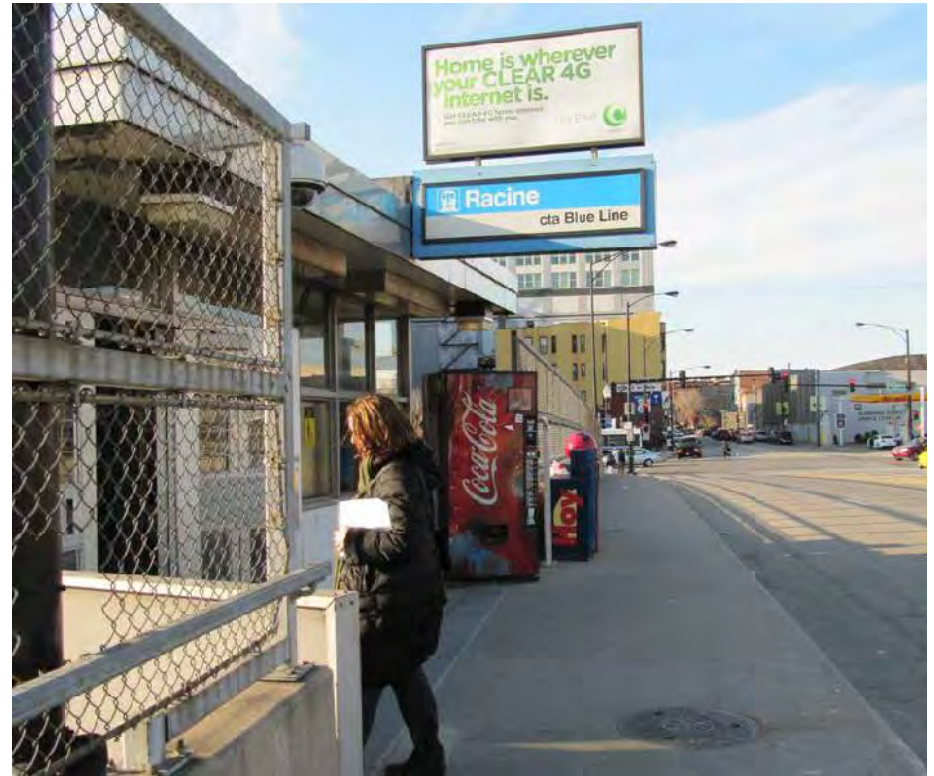
Chicago Transit Authority - Strategic Planning
 Blue Line Forest Park Branch Feasibility / Vision Study
Existing Conditions Assessment Report
Racine Station

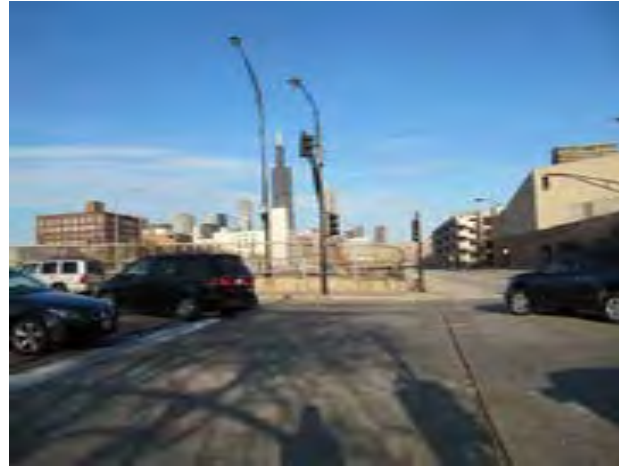
View of non-compliant curb ramp at Racine Avenue on approach to station. Note that there is no pedestrian crosswalk identified with stripping or signals

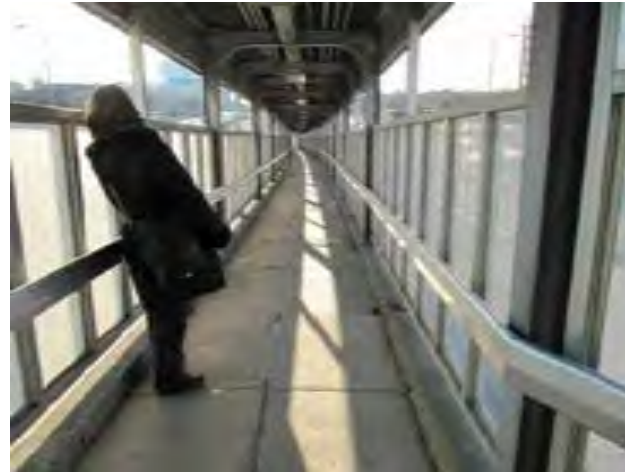
View of exit ramp at east end of platform

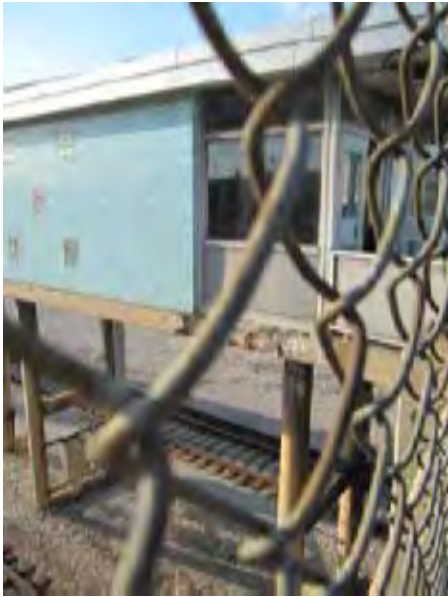
View of spalling concrete at the Racine stationhouse

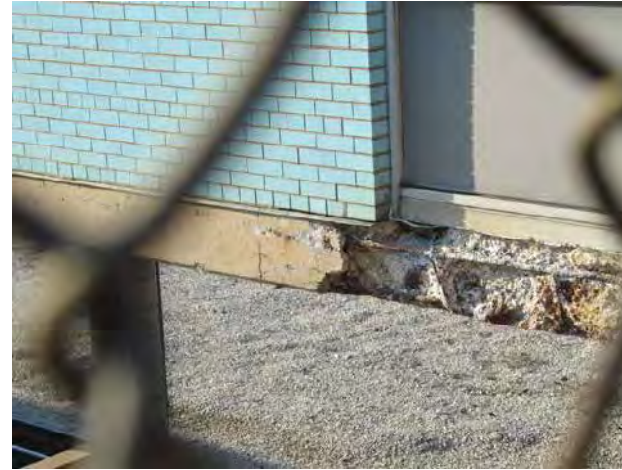
View of spalling concrete at the Racine stationhouse

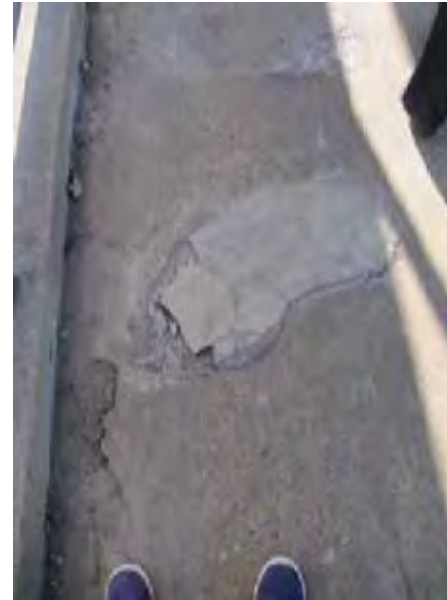
View of broken and cracked walking surface of ramp

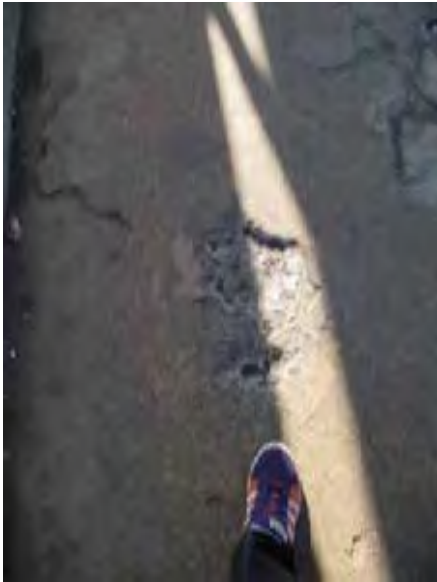
View of broken and cracked walking surface of ramp

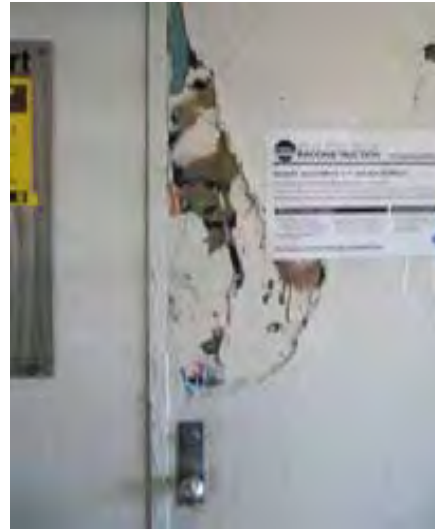
View layers of peeling paint in Loomis stationhouse

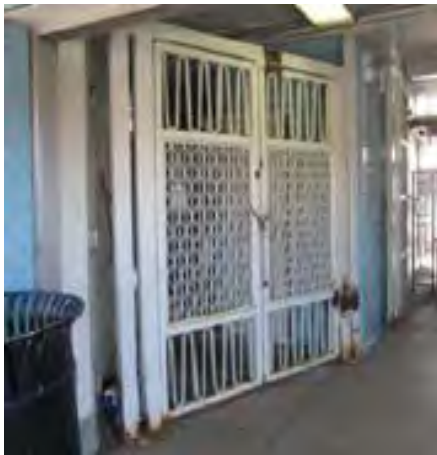
View of corrosion at gates in Loomis stationhouse

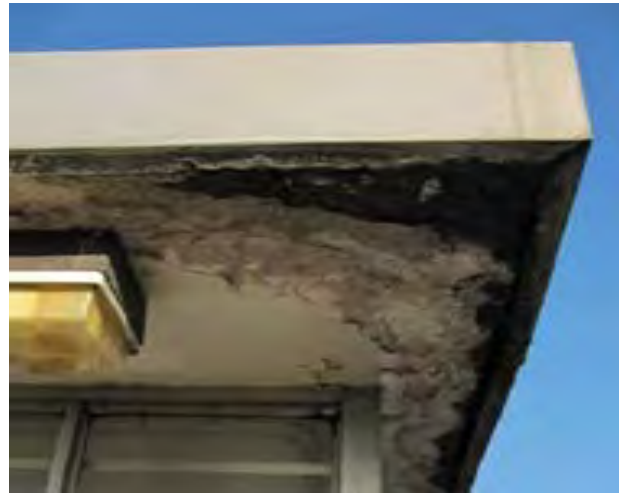
View extensive water damage at Loomis stationhouse roof eave

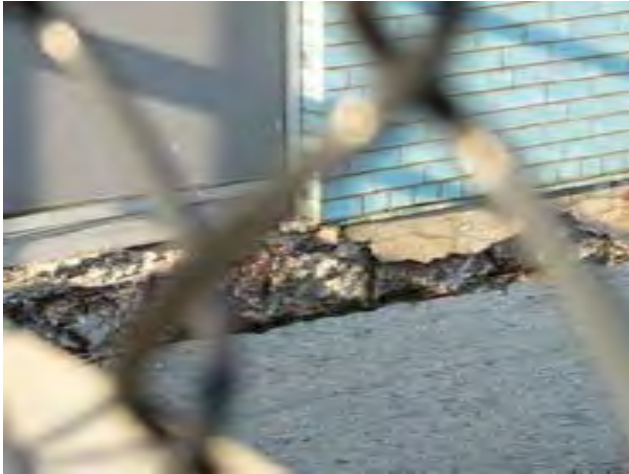
View extensive concrete deterioration and spalling at Loomis stationhouse

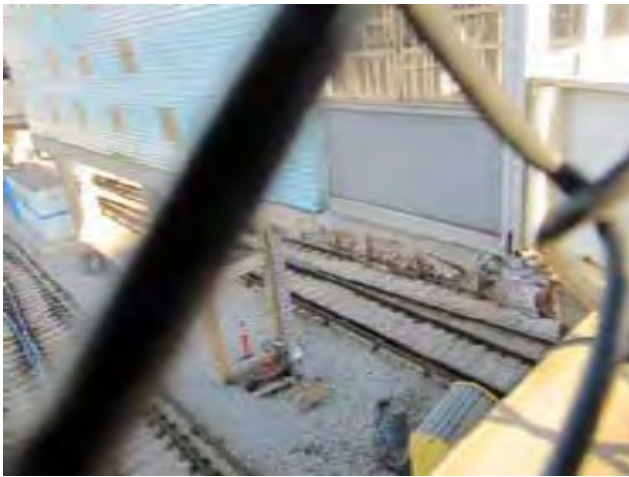
View extensive concrete deterioration and spalling at Loomis stationhouse

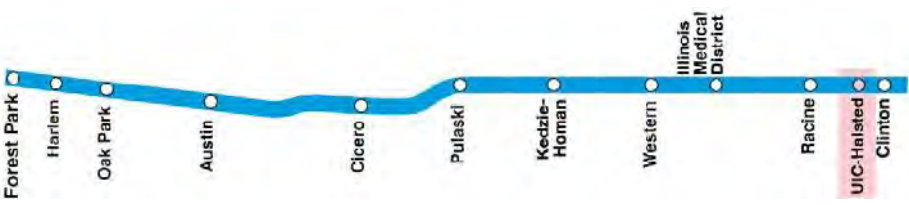
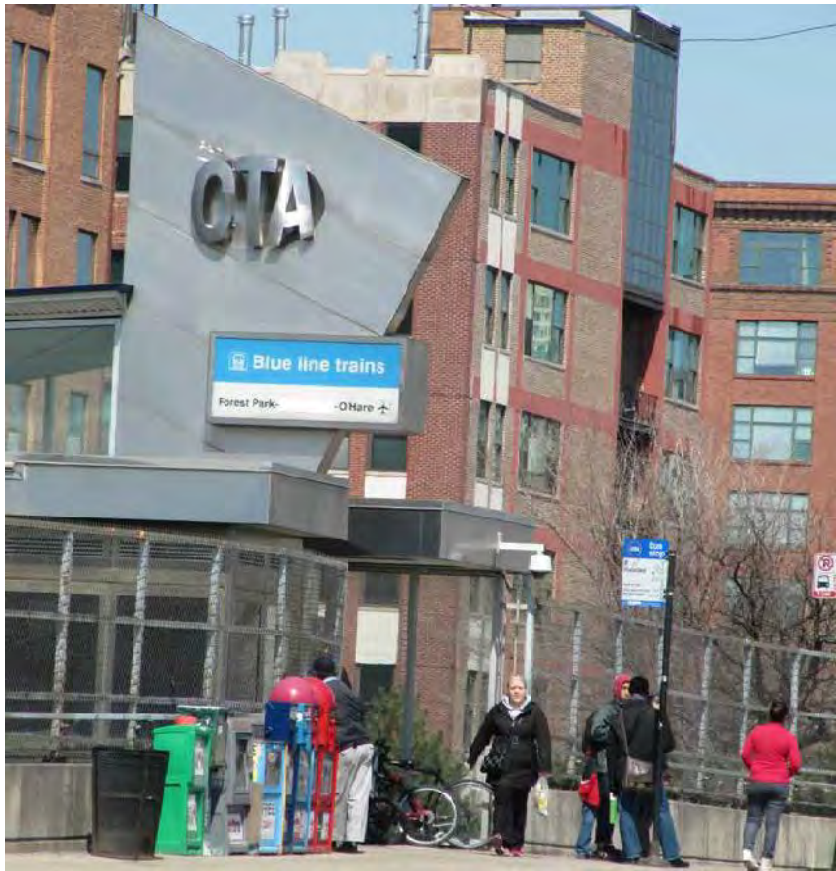
Chicago Transit Authority - Strategic Planning
 Blue Line Forest Park Branch Feasibility / Vision Study
Existing Conditions Assessment Report
UIC Halsted Station

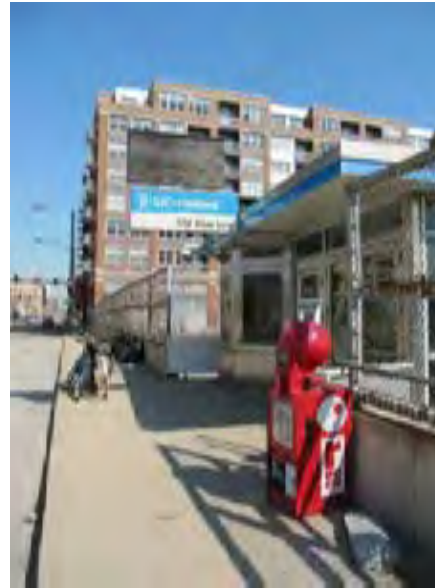
View of west stationhouse entry at Morgan Street

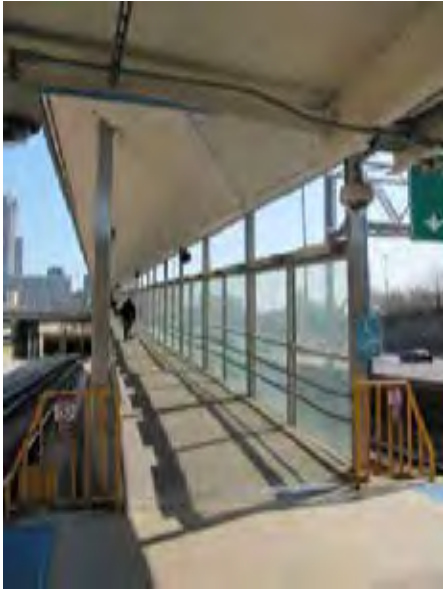
View of ramp exit at
east end of platform

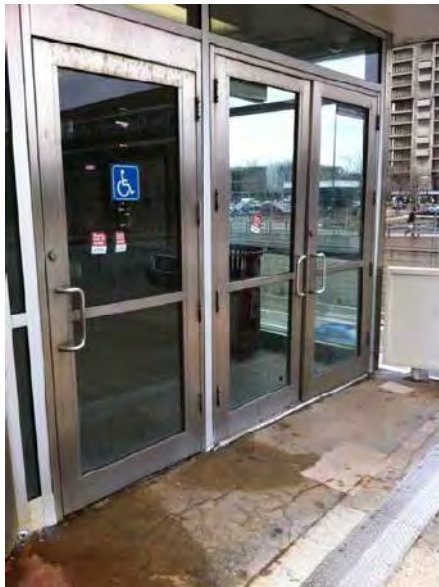
View of cracked concrete at entry door to Morgan stationhouse. Note that water is sitting on the concrete and that 2 out of 3 doors are out of service.

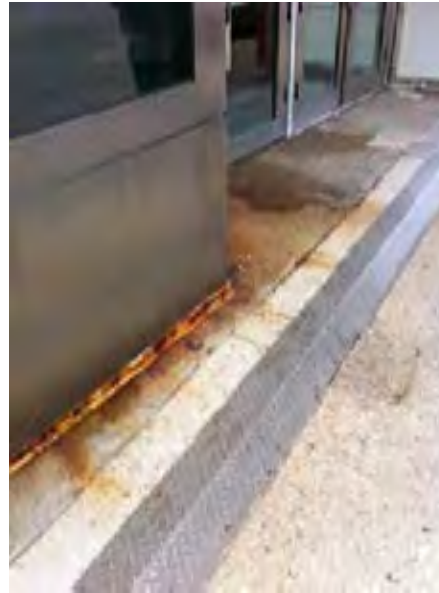
View of rusting and staining at base of customer service kiosk at Morgan stationhouse entry

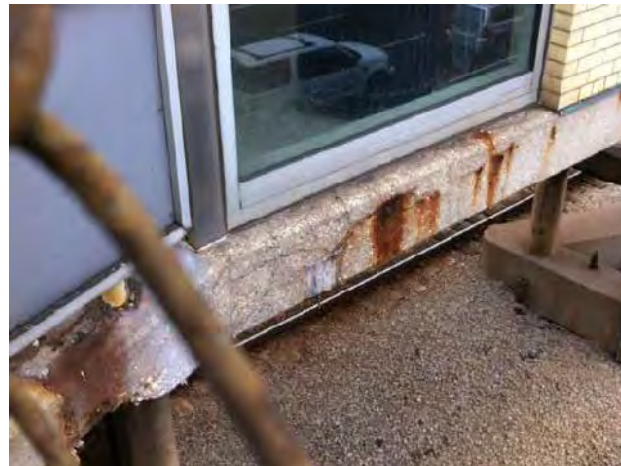
View of corrosion and rusting at concrete at base of Morgan stationhouse walls.

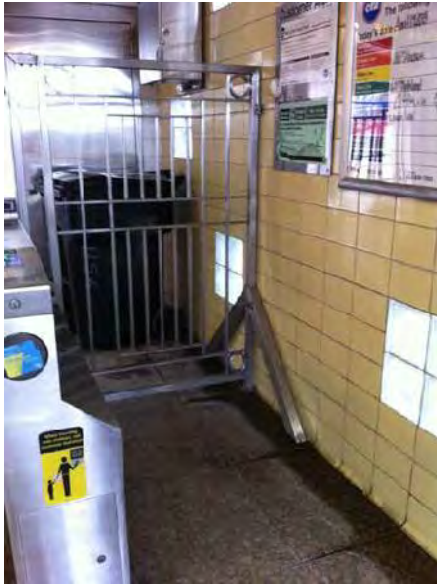
View of water infiltration in Morgan stationhouse

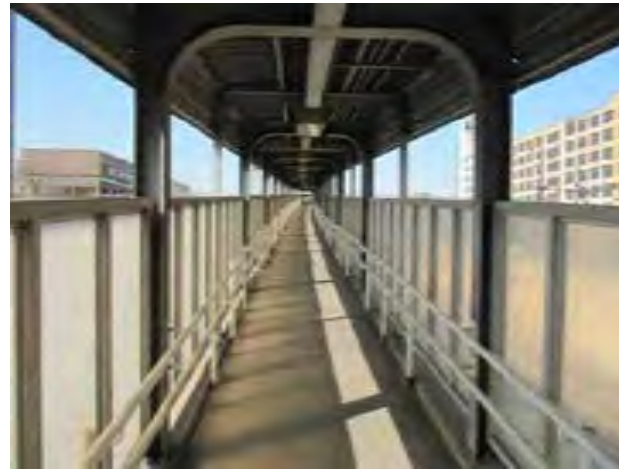
View of aged and scratched wind break panels at ramp to Morgan stationhouse

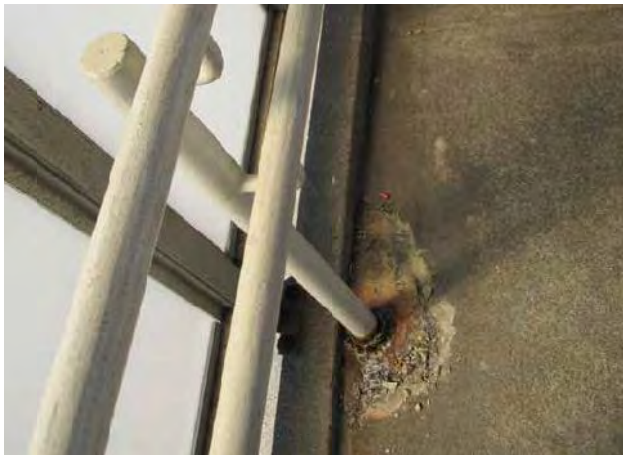
View of corrosion, rusting and deterioration at base of handrail supports in Morgan stationhouse ramp

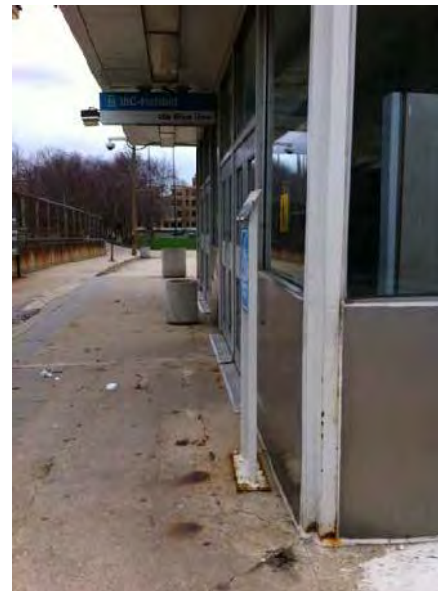
View of corrosion and deterioration at Peoria stationhouse

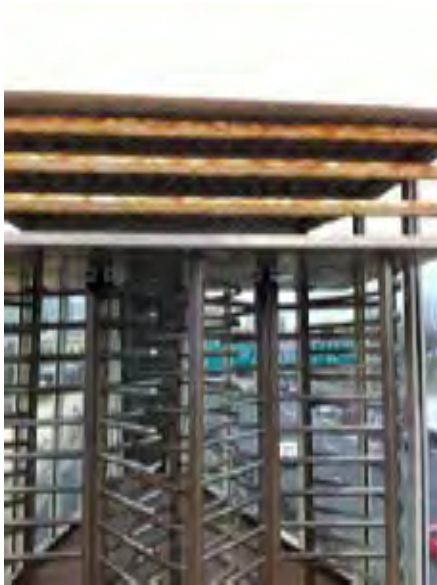
View of corrosion and deterioration at Peoria stationhouse exit only area

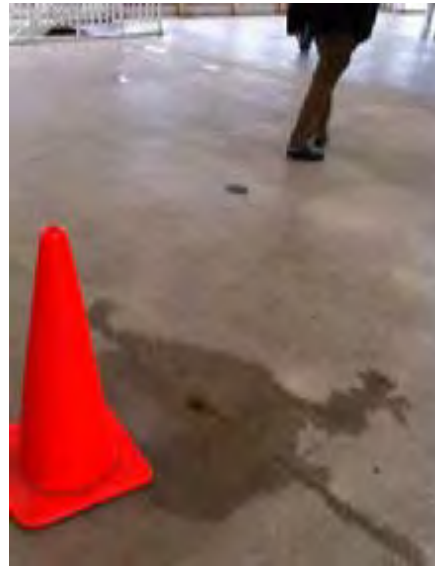
View of evidence of roof leaks at Peoria stationhouse skylight system

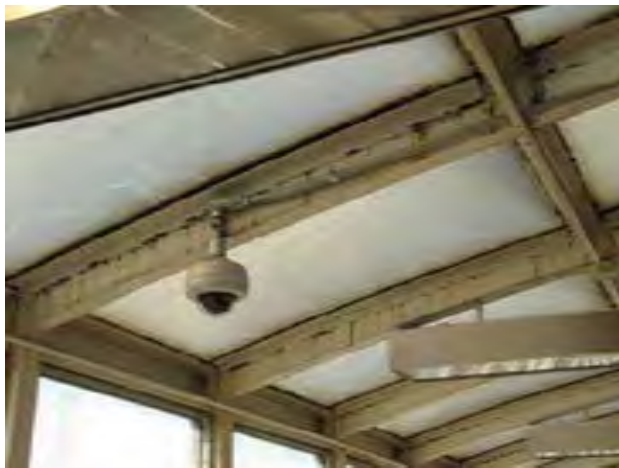
View of corrosion and deterioration at Peoria stationhouse skylight system

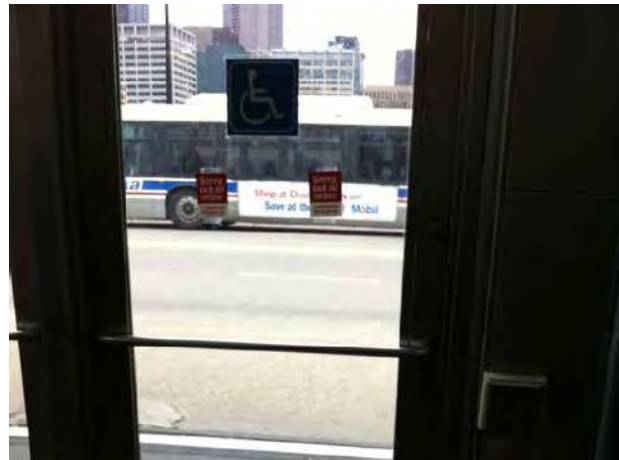
View of out of service ADA operator on Halsted stationhouse entry door

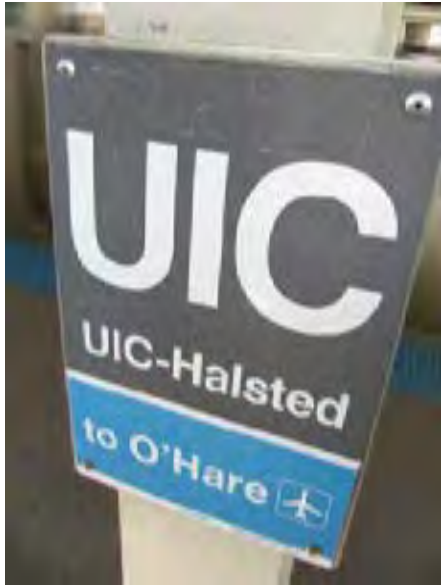
View of platform sign with graffiti scratched into surface.

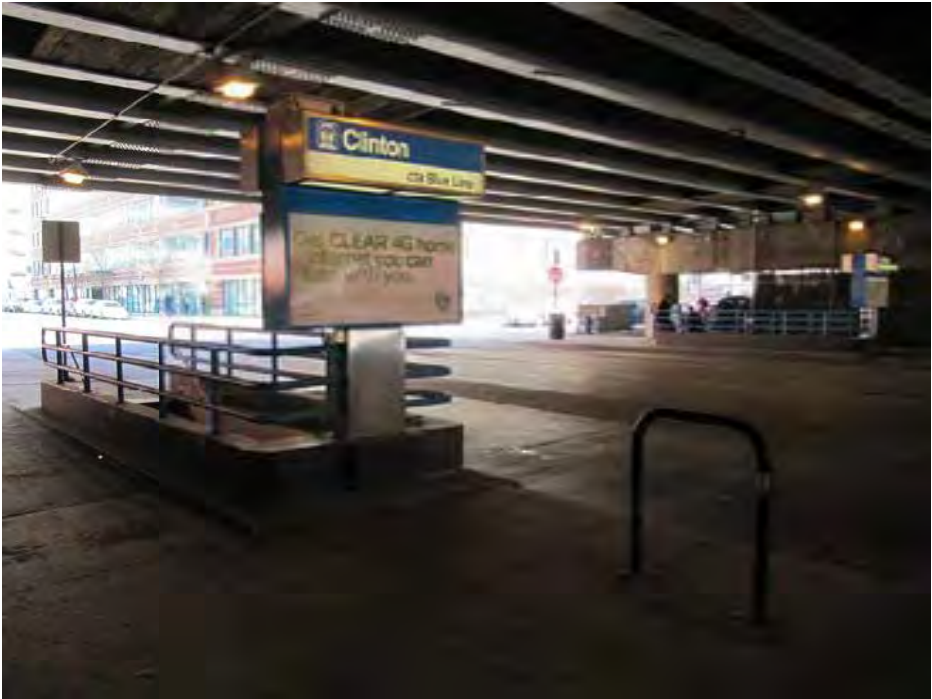
Chicago Transit Authority - Strategic Planning
 Blue Line Forest Park Branch Feasibility / Vision Study
Existing Conditions Assessment Report
Clinton Station

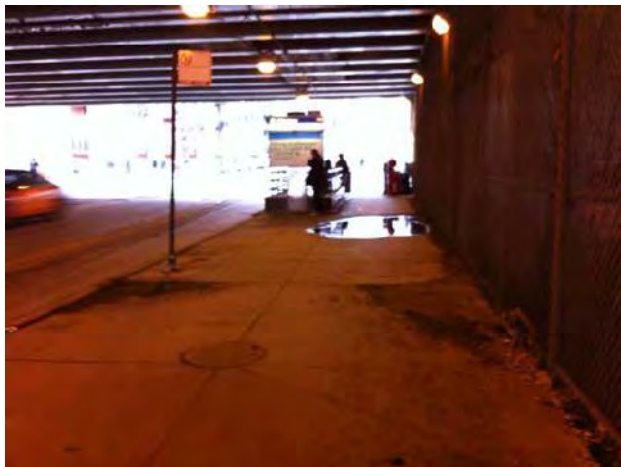
View of cracked and uneven sidewalks on approach along the west side of Clinton Street

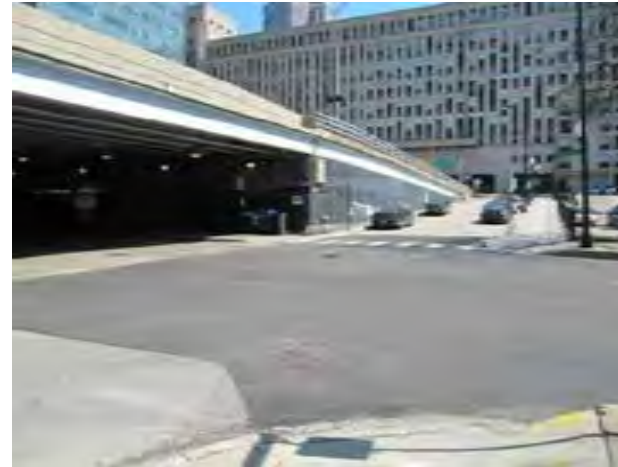
View of non-compliant curb ramp at Clinton and Congress Parkway, note crosswalk is not clearly marked at Clinton crossing.

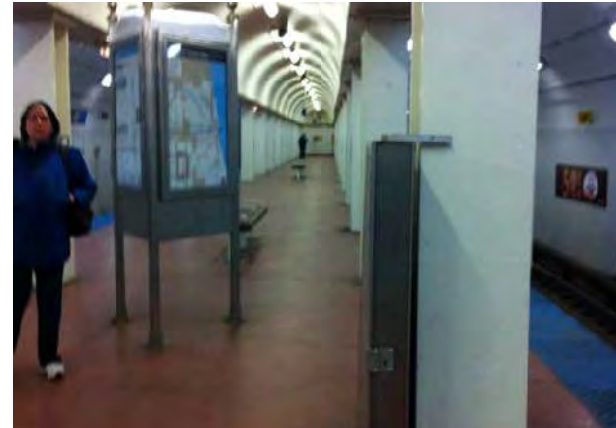
View of west end of platform showing long dead end area without means of egress.

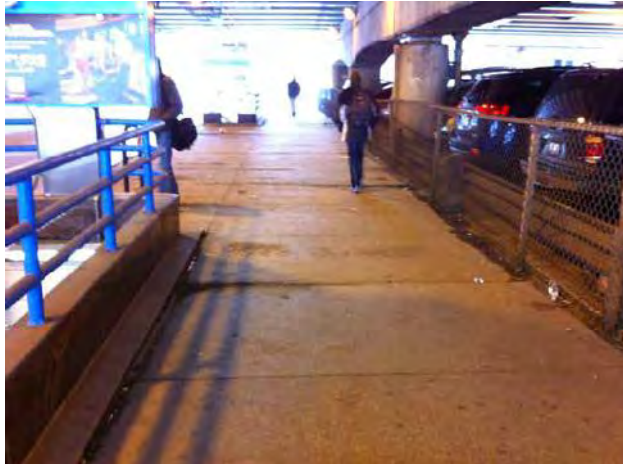
View of cracked and unlevel sidewalk at Clinton Street

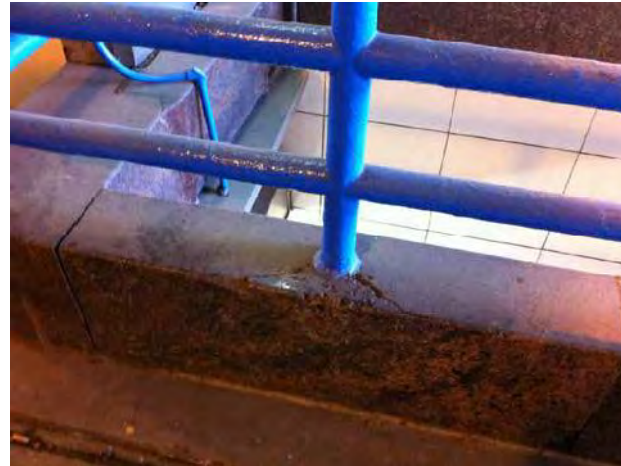
View of cracked stone cap at stair railing

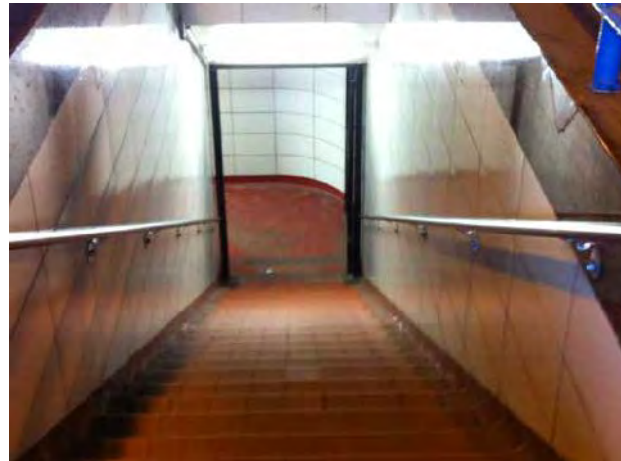
View of cracked and patch surface of entry stairs

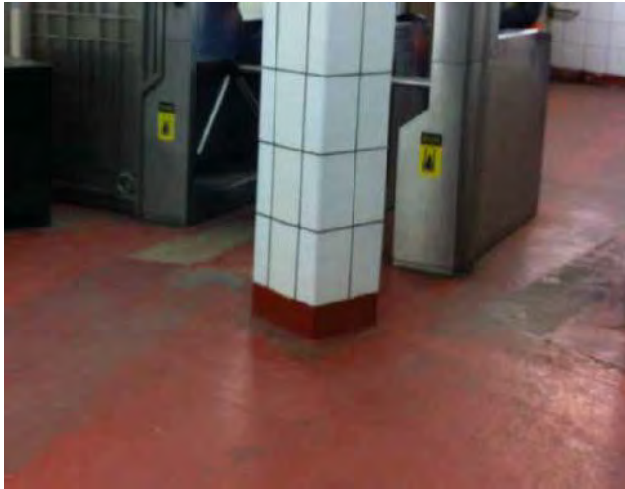
View of cracked and patched floor in station paid area

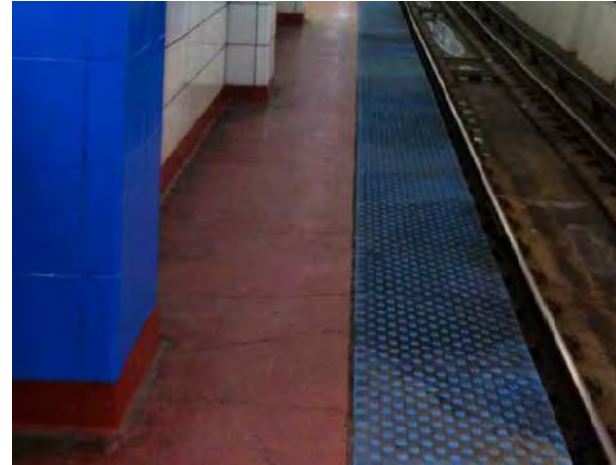
View of cracked platform surface

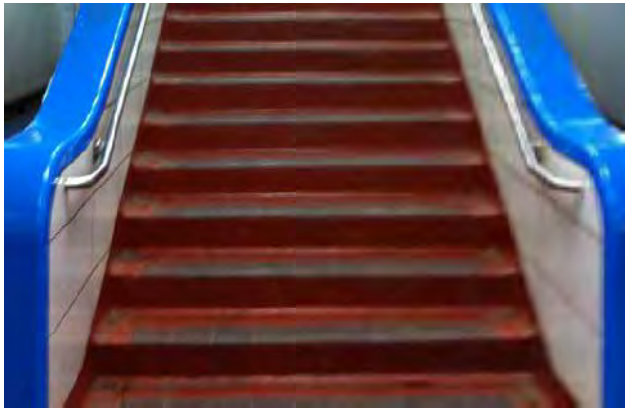
View of aged walking surface of stairs

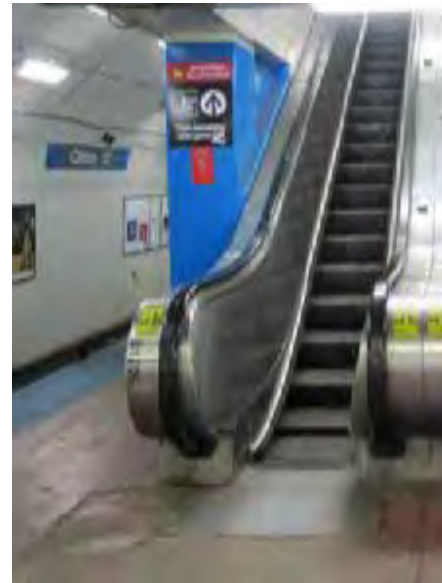
View of cracked and uneven platform surface. Note escalators do not have signage perpendicular to the enclosure walls to show passengers where escalators are located.
